## A New Angle on Safety! *Innovative Mobile Work Zone Barrier on Highway 115 Project*

## Water Works

### *An Innovative Alternative for Culvert Clearing*

### *Dingman Drive Bridge Repaired Using a Suite of Cost-Saving Innovations*

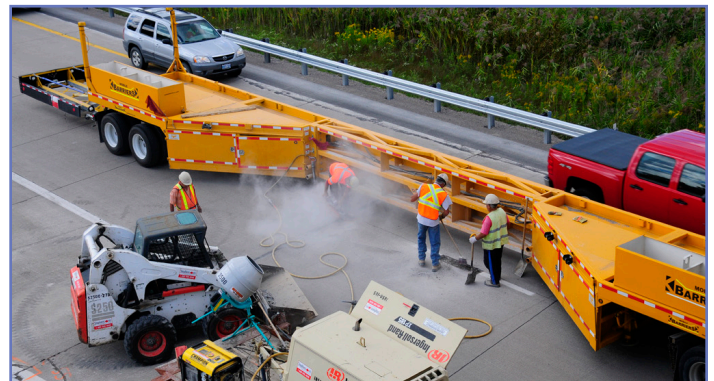
Road work takes place on Highway 115 while traffic moves safely along the other side of the mobile work zone barrier.

The mobile unit performed extremely well in providing a safe area for workers and was positively received by other external agencies such as Ministry of Labour and Ontario >

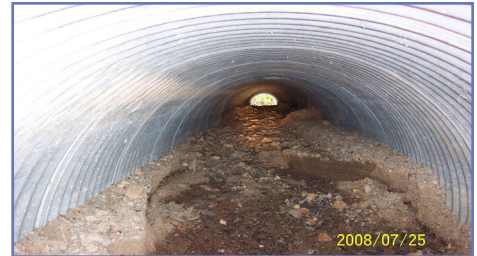
The culvert on Highway 590 filled with gravel and rocks after a June 2008 rain storm.

When a major storm in June 2008 clogged a Highway 590 centreline culvert with gravel and rock, blocking 75 percent of culvert capacity, MTO staff conceived an innovative solution to wash out the culvert. MTO contacted the local Fire Chief to develop a culvert clearing plan using a few interested volunteers and a high pressure fire hose. The culvert in question was in good condition and absent of standing water.

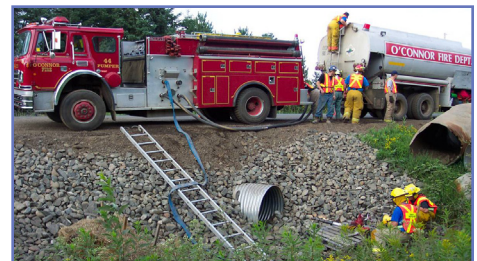
Township of O'Connor Fire Department assisted MTO in clearing the culvert with an experimental high-pressure water method.

On the day of the trial, the ministry's Area Maintenance Contractor prepared the site by using a backhoe to dig a 1m x 1m x 0.5 m hole at the culvert outlet, to serve as a sump for material to be washed out. Volunteers from the Township of O'Connor Fire Department arrived with a pumper truck and a tanker truck filled with 20,000 litres of water. Fire Department volunteers then set up a ground mounted, mechanically aimed, monitor nozzle at the inlet end of the culvert. The 3 cm monitor nozzle, attached to a 6.35 cm pressure line connected to the tanker and pumper trucks, aimed a precise water stream to clear the furthest reaching point of the culvert debris first. Water was pumped at 1,230 litres per minute at 100 psi.

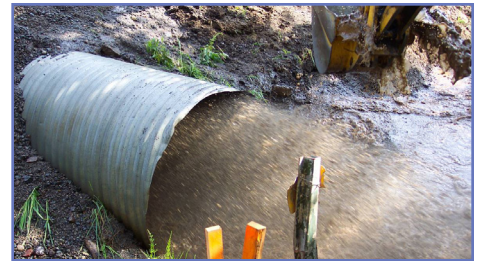
Culvert debris was easily displaced and discharged.

method would be successful. After 28 minutes and 40,000 litres of water, 20 tons of debris were flushed from the culvert; in fact, gravel and rock exited the culvert faster than the backhoe could clear the sump at the end of the pipe. Ministry staff concluded that any pipe not more than 80 per cent blocked with material, with a span short enough to reach near the end with a similar pump/nozzle configuration, could be flushed out very economically using this method.

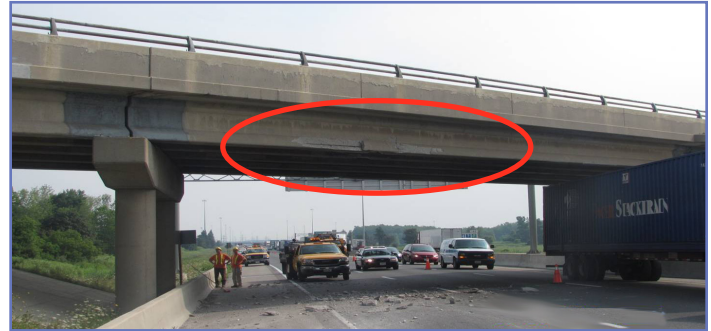
Damage to the Dingman Drive Bridge, looking eastward.

On August 3, 2010, a truck carrying a hydraulic excavator struck the four-span Dingman Drive Bridge over the westbound lanes of Highway 401 near London, Ontario. The truck hit three out of five pre-stressed concrete bridge girders, resulting in extensive damage. Several innovative products and processes were used to perform the repairs, resulting in cost and time savings for the ministry compared to full girder replacement.

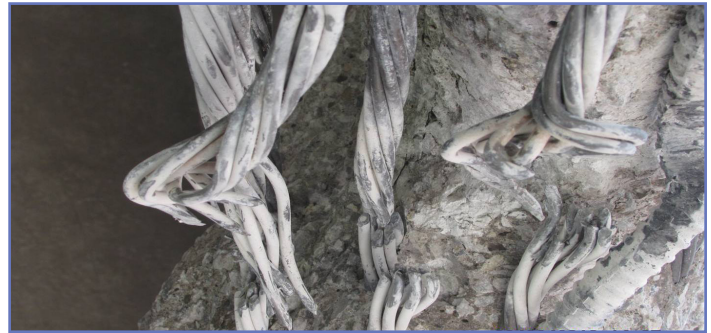
Collision-damaged strands on one of the bridge girders.

Developed in the United States, the *Grabb-It*® is a coupler system that permanently reconnects broken strands in bridge girders, to restore the load carrying capacity of the structure, without having to replace the damaged girders. The *Grabb-It*® device is attached to each end of the severed strand and a threaded coupler (similar to a turnbuckle) is tightened, thereby reinstating the prestressing force in the strand. Although MTO has been aware of the *Grabb-It*® system for a number of years, this repair project was the ministry's first opportunity to use the device. Before the couplers were used on the repair itself, MTO staff practised with the *Grabb-It*® on a model and developed a detailed procedure for the contractor to install the devices. Working with the *Grabb-It*® on site proved more difficult than expected to obtain the desired force in the strands. Force in each strand was determined using a torque wrench to tighten the coupler device and measuring the elongation of the strand. A total of six *Grabb-It*® couplers were installed on two girders, reinstating the pre-stressing force in the girders close to their pre-collision status.

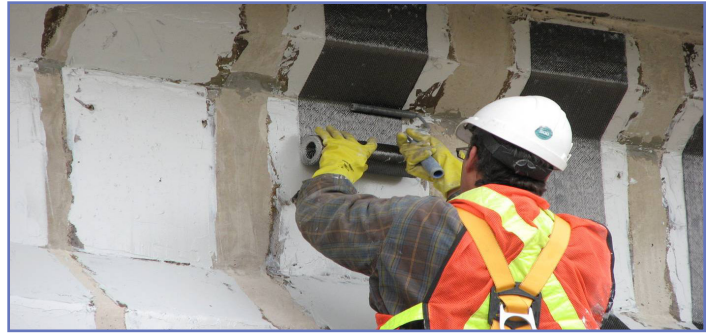
Application of CFRP strips with a roller.

Sheets of woven **Carbon Fibre-Reinforced Polymer (CFRP)** fabric were placed over the concrete repair areas to further strengthen and protect the girders. CFRP fabric is light and can be readily attached to the contours of a concrete girder with an epoxy adhesive system. Three layers of CFRP strips were installed on the underside of the girders and evenly spaced vertical strips of CFRP were installed on the webs of the girders using a multi-step process. The proprietary process included diamond grinding all sharp concrete edges, application of a primer and an epoxy putty, rolling the CFRP fabric onto the epoxy putty, coating the CFRP with a saturant and finally covering the entire repair area with an ultra-violet protective coating.

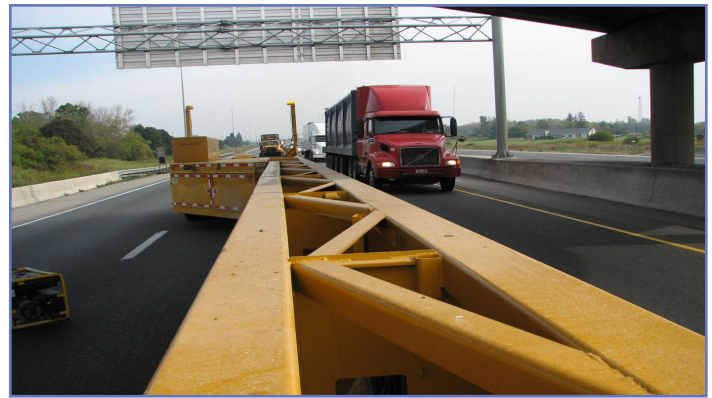
Mobile Traffic Barrier in use under the Dingman Drive Bridge.

A **Mobile Traffic Barrier** was used for the duration of the Dingman Drive Bridge repairs to protect construction workers from freeway traffic. The mobile barrier unit consists of a trailer that is towed into place by a standard truck tractor and then parked to provide worker protection. First used by MTO on a project on Highway 115, the Mobile Traffic Barrier continues to impress contractors and staff in several ministries because of its ease and speed of set-up compared with conventional work zone protection equipment, such as temporary concrete barriers. To minimize disruption to Highway 401 traffic, two of the three westbound lanes were closed on a nightly basis to complete the repairs on the Dingman Drive Bridge. The Mobile Traffic Barrier was removed each morning, opening all lanes during peak traffic hours.
