## New Scanning Technology Defers Expensive Culvert Rehabilitation

Managing buried infrastructure has increasingly become a priority for asset owners across North America. Much of today's highway infrastructure was deployed decades ago and have reached or passed their designed life expectancy and are scheduled for rehabilitation or replacement. To assist in the identification of soil voids, which potentially lead to critical culvert failures, the Ontario Ministry of Transportation (MTO) hosted a pilot to test a new scanning technology.

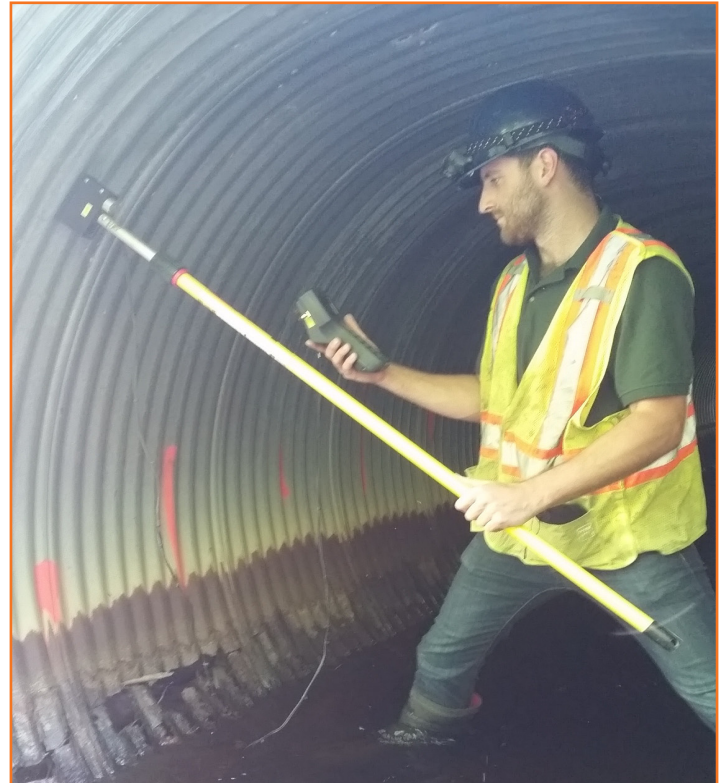
*A culvert inspection technician uses the hand-held wand to identify soil voids.*

During the pilot, a unique new condition assessment tool, a lightweight scanning wand called the Single Side Handheld Radiation Probe, was deployed to assess soil integrity behind Ontario's culvert walls. The wand is a unique infrastructure condition assessment tool, capable of non-destructively mapping culvert wall soil compaction more reliably than current visual or acoustic inspection methods.

The wand takes the guess work out of soil void detection and is used in conjunction with tablet software that collects and stores all culvert scanning data. The wand

can be operated by any technician and requires only a micro-curies strength isotope (ionizing radiation) for operation. It is spectral calibrated to generate heat maps of each inspected culvert which displays soil void sizes within one-third of a centimeter.

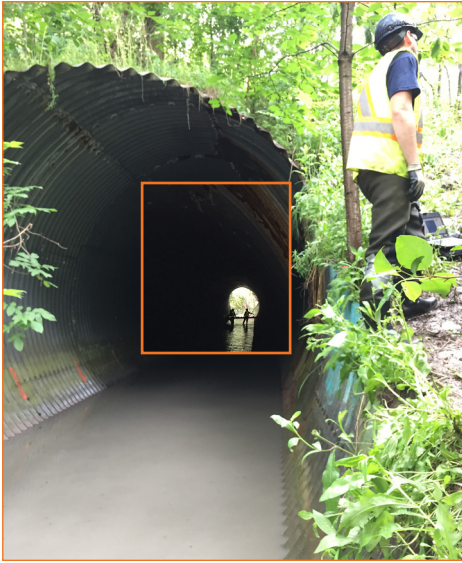
*To show the scale of this culvert, a technician stands on the right embankment as inspectors scan near the end of a 106m culvert under Ontario's Highway 406, in St. Catharines, Ontario.*

The culvert inspection at Highway 406 provided a good case study for the scanning technology. Visually, the culvert appeared to be nearing the point for

rehabilitation or replacement but scanning results revealed that the culvert had several years of service life left and should remain on the ministry's list of monitored culverts.

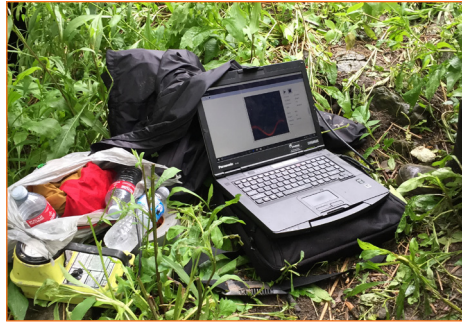
*A monitor on the embankment at a culvert site, receives data from the BCT™ scan to build a visual image of soil integrity, shown on the right. It takes six minutes for a scanned culvert wall image to transmit to the on-site computer monitor.*

Each BCT™ diagnostic scan transfers data to an on-site laptop, building a digital image of the soil densities behind the culvert wall, in roughly six minutes.
