## Re-Establishing a Brand

### *A New Ontario Standard for Snow Removal Equipment Visibility*

## "Double Duty" Snow Plows

### *The Ministry Is Raising Public Awareness about Tow Plows*

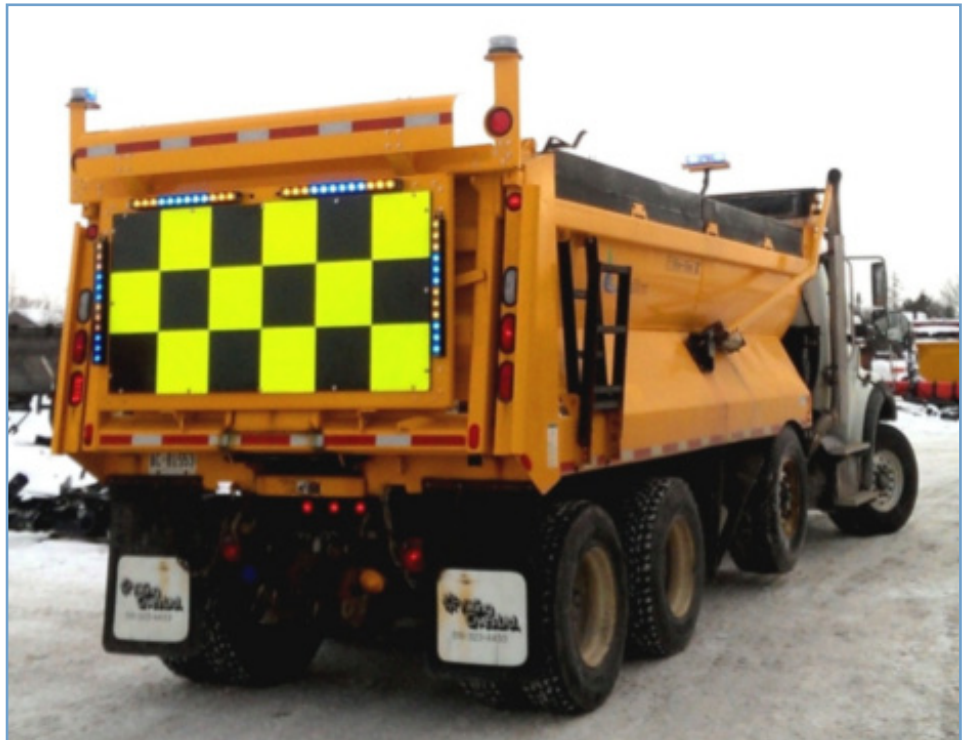
The new MTO standard for winter maintenance equipment lighting and visibility

Following this literature review and workshop, an in-house study was conducted that focused on lighting and visibility. A major focus of the study was on the conspicuity panel, which is the large panel on the back of snow removal equipment that helps to identify it. The research determined that these conspicuity panels should be consistent in appearance for recognition purposes.

In November 2013, MTO conducted tests with nine different colour and sheeting combinations during daytime and nighttime winter conditions. The tests demonstrated that the best conspicuity panel is a checkerboard pattern in fluorescent yellow-green and black.

Tests were also conducted on lighting through the winter of 2013/2014. MTO's research determined that the conspicuity panel should be augmented with blue and amber LED lights in an "H" pattern to convey the height and width of the vehicle, with the upper arms including stop/turn lights, and culminating in blue and amber beacons. Research demonstrates that blue is the most conspicuous colour both day and night, and needs the least intensity, thereby reducing glare for motorists. Research also demonstrates that a combination of colours is more effective than a single colour warning light. >

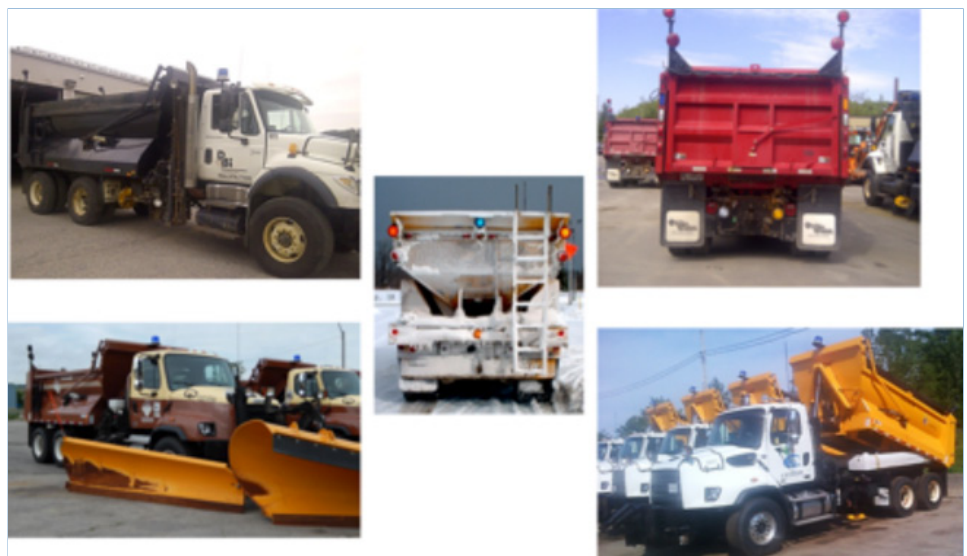
Snow plows operating in Ontario today lack a consistent "brand identity".

MTO's yellow and black snow removal equipment had its own "brand identity" before plowing was done by contractors. Since the mid-1980s, we have progressed to a point where 100 percent of winter maintenance in Ontario is done by contractors. As a result, snow plows have many differences in appearance and it can be difficult for motorists to identify and appropriately respond to snow removal equipment on the highways.

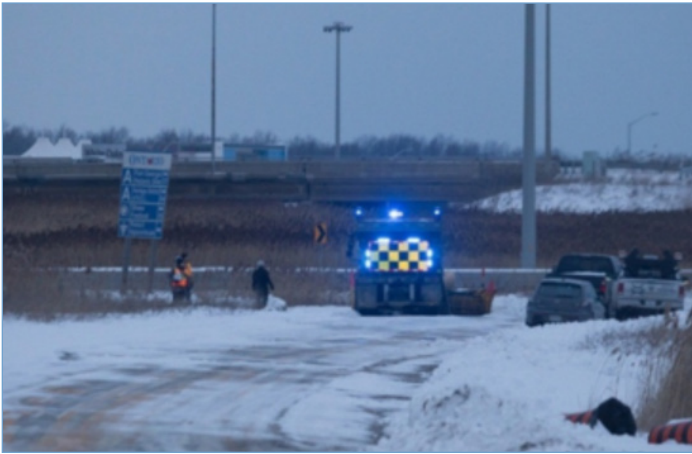
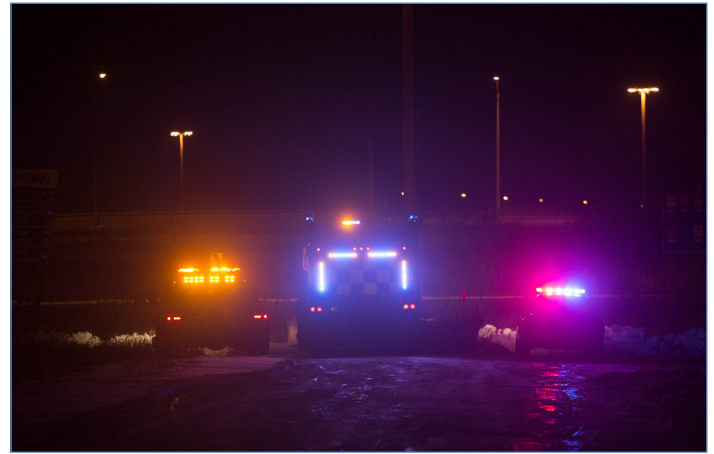
Testing the new lighting and visibility standard in winter conditions and at night.

The study recommended that the existing roof lighting on snow removal vehicles be replaced with an amber and blue LED light bar. Rear lighting effectiveness was determined to be best when the amber lights remain continuously illuminated, while the blue lights flash at a synchronized 1Hz rate (one flash per second). This slower rate of flashing subconsciously indicates to motorists that the vehicle is moving slowly and avoids any potential issues associated with higher flash rates or strobes.

Ambient sensors were also studied and they were ultimately recommended because they can tailor the intensity of lights for daytime and nighttime visibility. At night, the ambient sensor reduced the light output to approximately 65 per cent to reduce glare while still alerting motorists.

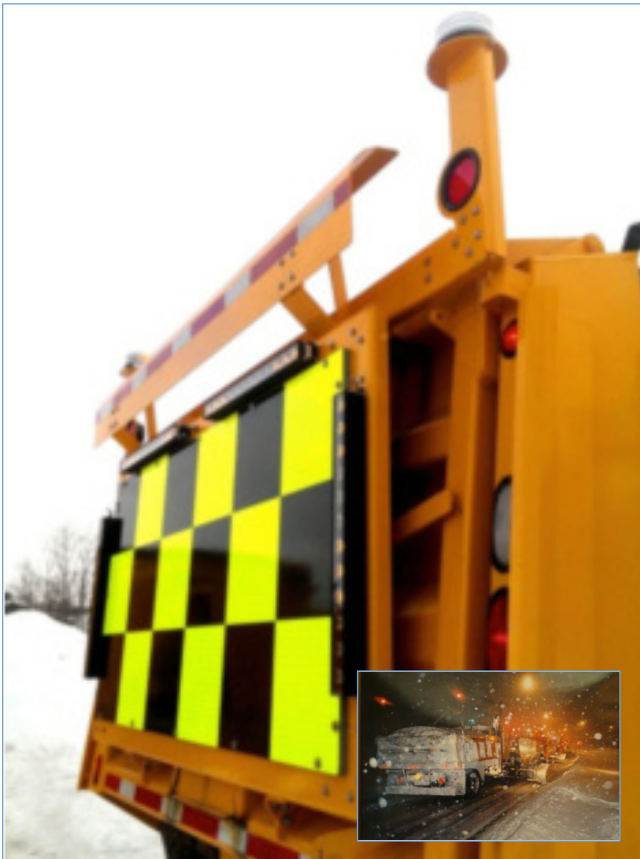
Air foils reduce snow, slush, and salt build-up on the rear lights and panel.

Finally, MTO's research included an analysis of air foils that had been developed and implemented in Alberta to prevent snow, slush, and salt from building up on the rear lights and conspicuity panel reducing their effectiveness. These air foils were effective in the tests and they are included as part of the proposed new standards.

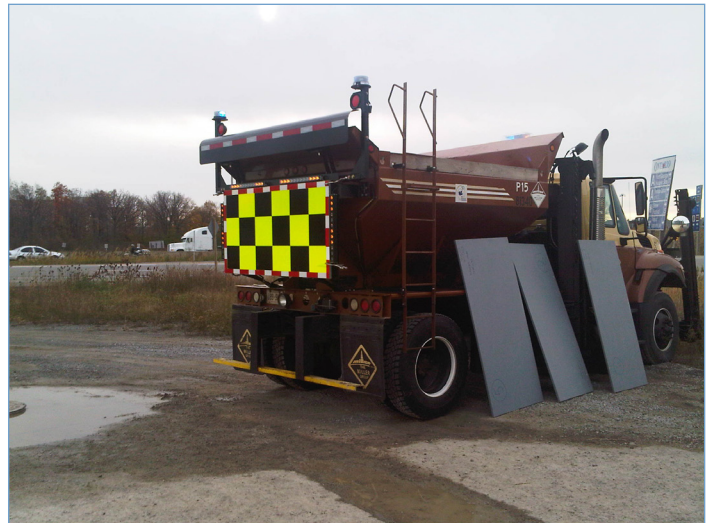
Test panel trials during the conspicuity study.

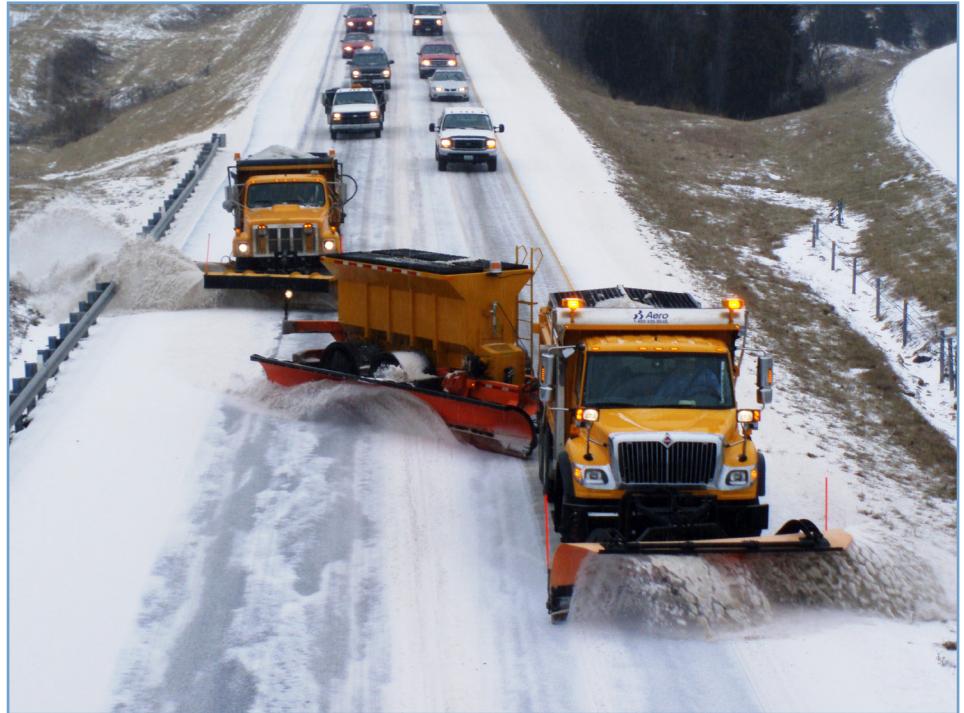
A tow plow, and regular snow plow, in "echelon" operation.

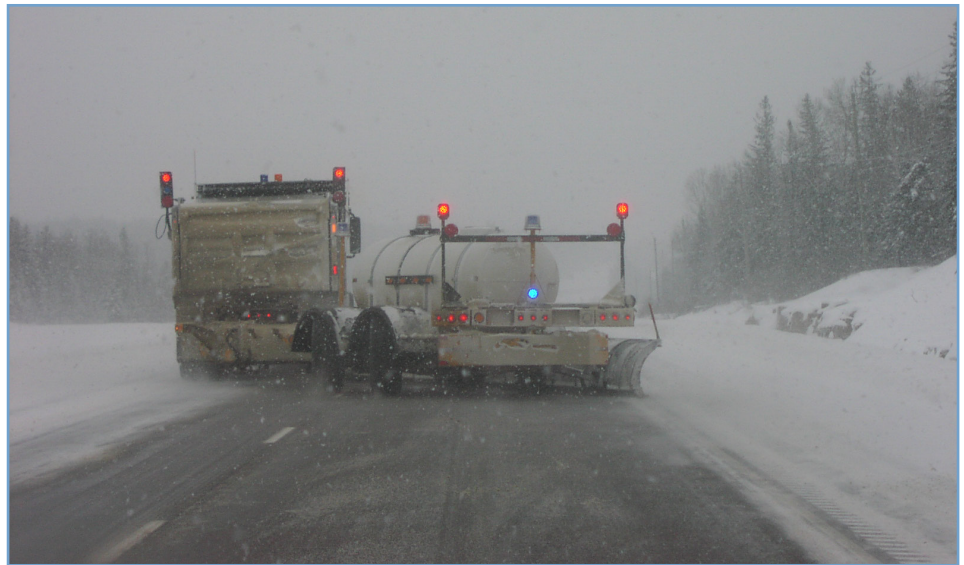
A tow plow in operation, with the plow extended out, to the right. The increased clearing path is evident.

**W**inter can be a particularly challenging season for drivers across Ontario and winter maintenance is certainly a challenge for contractors. Many of the Ministry of Transportation's (MTO) maintenance contractors are using "tow plows" to clear snow from Ontario's highways. Tow plows are trucks with a standard plow mounted on the front and an additional plow on a steerable trailer towed behind the truck that is extended out, to the right, when in operation.

When deployed, this configuration increases the effective clearing path to allow the tow plow to clear the adjacent driving lane.

This two-lane wide clearing path eliminates the need for a second piece of equipment on the highway, which means clearer roads in fewer passes with less equipment and reduced vehicle emissions.

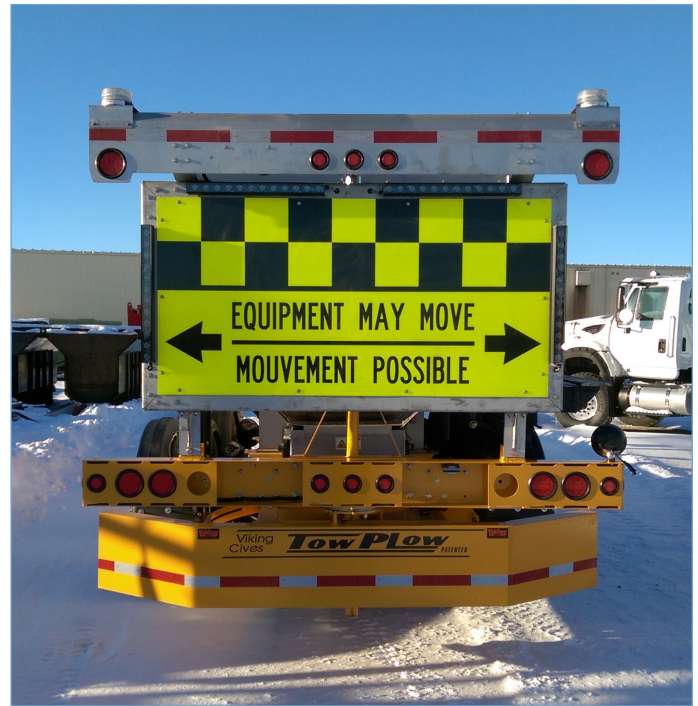
New sign on the back of a tow plow.

The ministry has also developed standard messaging for signs on the back of tow plows to alert drivers that the plow can swing to the right, and then swing left, back in behind the truck.

This sign provides an additional warning to drivers to stay well back from winter maintenance equipment, and particularly out of the 'swing radius' of a tow plow.
